THE CONSERVATION OF THE ORPHEUS MOSAIC AT PAPHOS, CYPRUS

THE GETTY CONSERVATION INSTITUTE

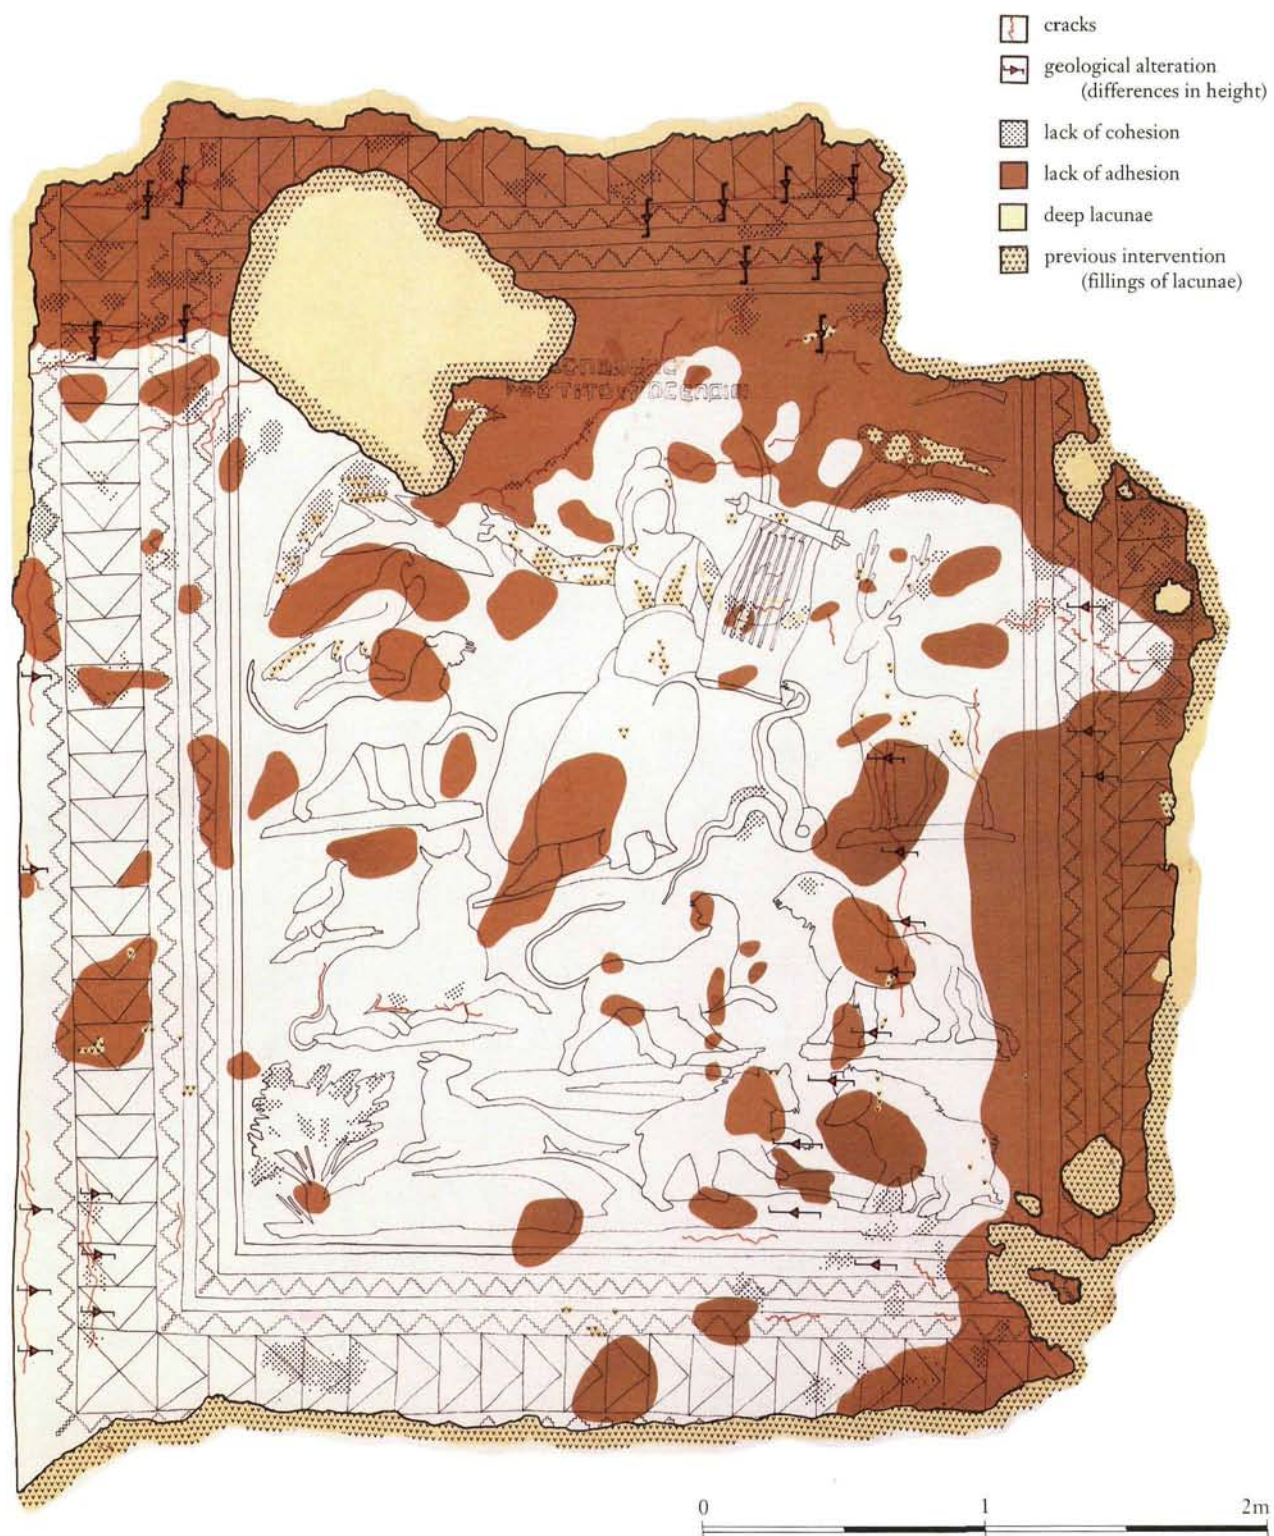
Plate 6. Condition of the support layers of the Orpheus mosaic prior to conservation.

At the time of its excavation, the Orpheus mosaic appeared to be in good condition. The depiction of two birds at the top (west) end of the mosaic had been destroyed by the root action of bushes, leaving large lacunae (see Pls. 1,2). Other roots had dislodged the tesserae and passed under most of the inscription and Orpheus' extended right hand, where the tesserae lacked any firm attachment.

Further damage to the mosaic was evident on the southeast and west sides, where stone-robbing from the walls of the room had destroyed the edges of the mosaic. Most of the walls had been robbed to below their foundations, with the exception of that to the south where the area of wall-painting was still preserved. The mosaic appeared otherwise to be in good condition, despite lying only a few centimeters below the ground surface. It was not uniformly flat, however; a hump running the entire length of the north side of the mosaic was later confirmed to be the result of an underlying wall.

The subsidence caused by the partial support of the mosaic on this underlying wall became more pronounced as the subsoil dried out following excavation, and minor cracking began to appear. It was also suspected (as proved to be the case) that much of the mortar of the setting-bed had lost its cohesion (see condition drawings, Pls.6,7). A consolidation of the mosaic in situ would therefore have been of limited effectiveness, and it was decided to lift the Orpheus mosaic and to provide it with a new support that would be impermeable to capillary rise of moisture before replacing it in situ. In the meantime, the lacunae and the broken edges of the mosaic were mortared for protection.

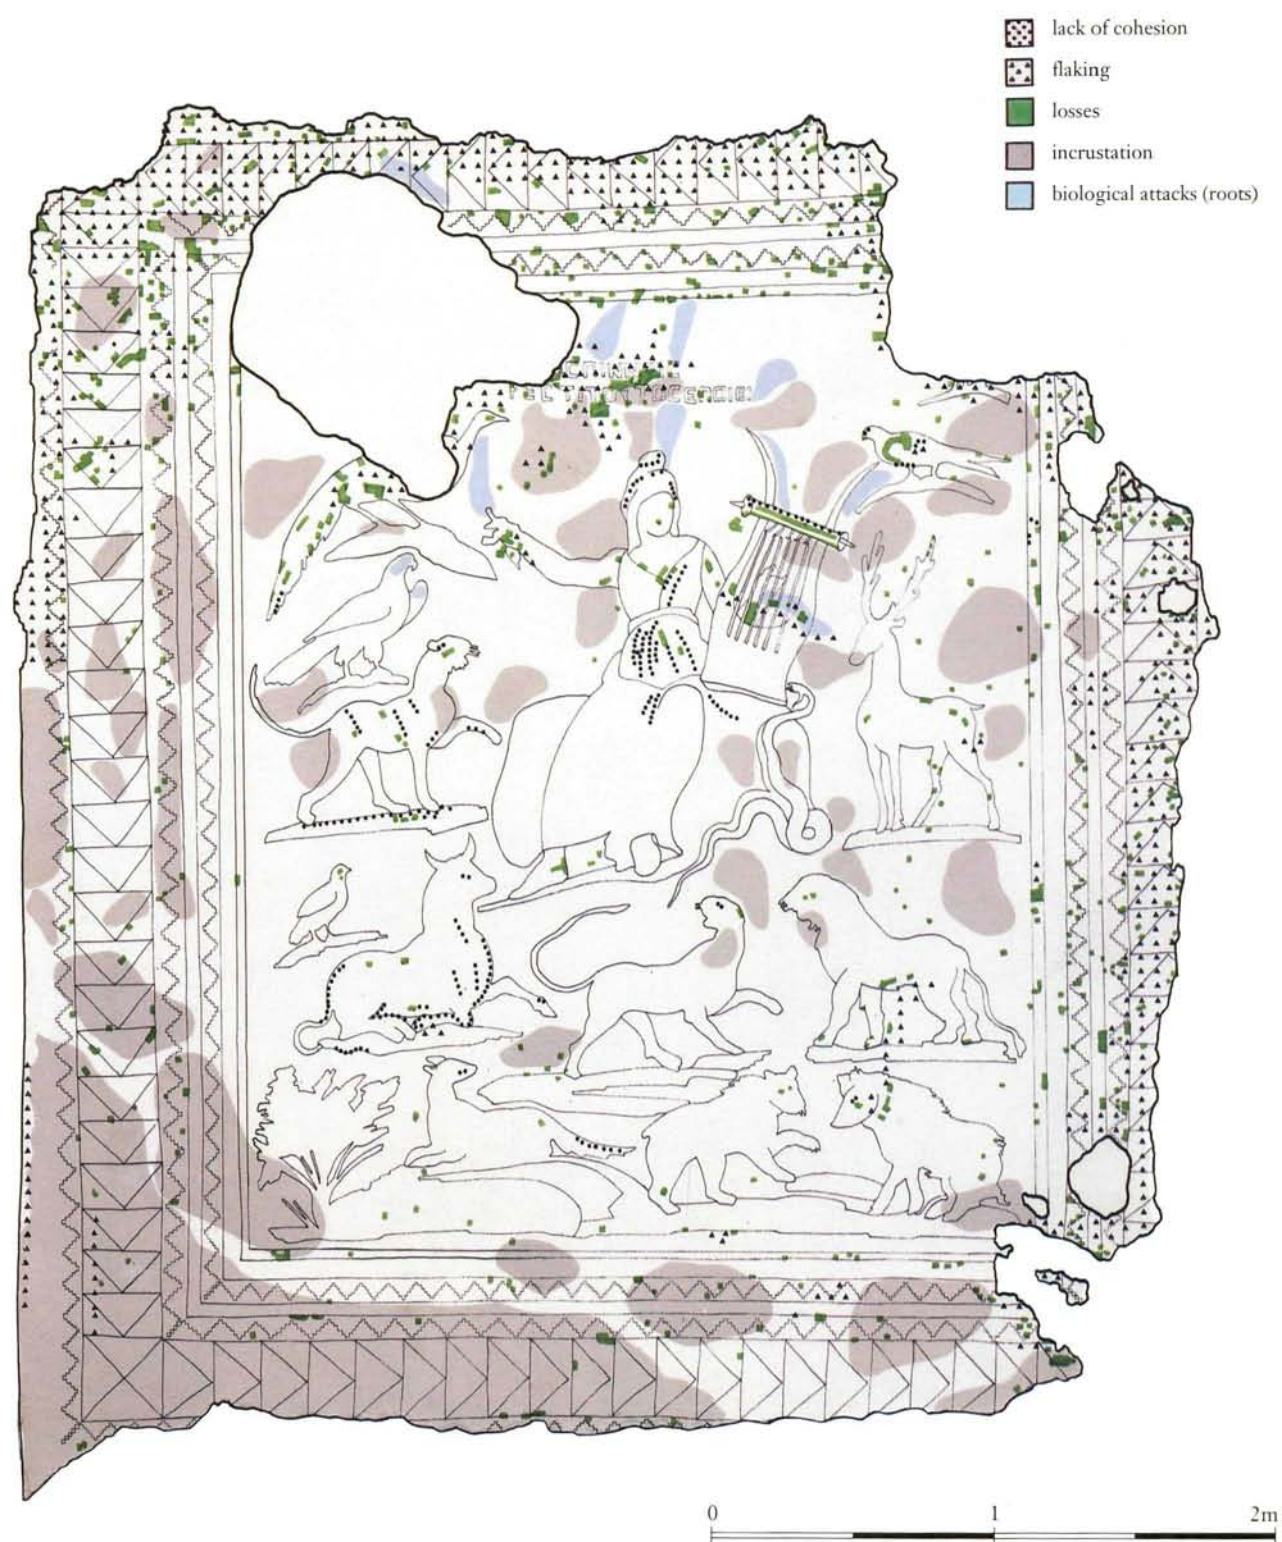
Plate 7. Condition of the tessellatum of the Orpheus mosaic prior to conservation.

Before proceeding with the application of a facing to the mosaic, it was necessary to preconsolidate those areas lacking cohesion (see Pl. 7). On fragile red stone tesserae where lack of cohesion was particularly severe, Paraloid B72 (ethyl methacrylate–methyl acrylate copolymer) in Chlorothene (1,1,1 trichloroethane) was infiltrated in different concentrations (3% to 6%) until complete saturation and reestablishment of cohesion was achieved. Similar operations, using ethyl silicate as a consolidant, were carried out on the tesserae of glass affected by flaking phenomena.

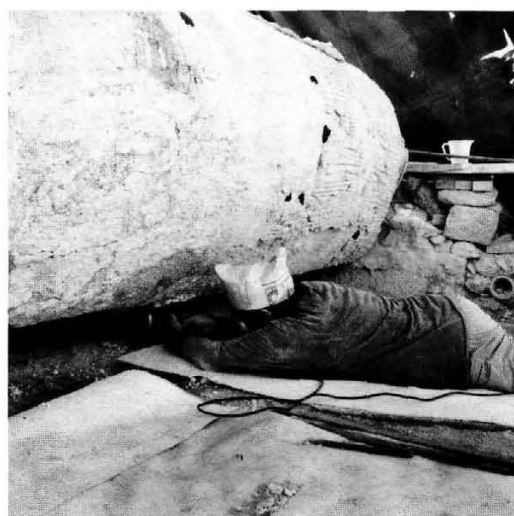
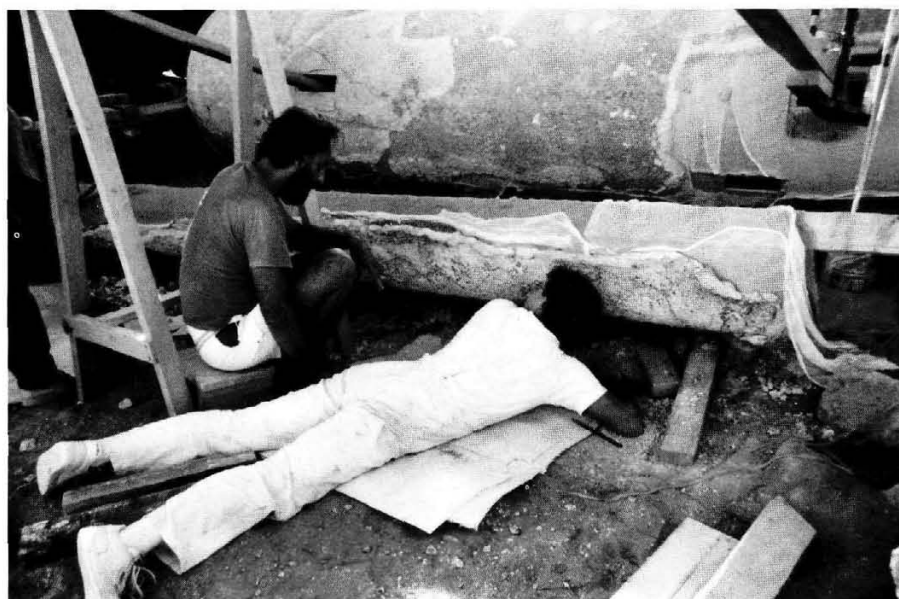
Detachment of the south side of the mosaic proved quite difficult. In this area, flanking the surviving wall, the ancient mortar was in good condition and tenaciously resisted attempts to separate it from the mosaic surface. It was necessary to carry out the cutting with a fraise (a tool with a rotating disk for cutting

Figure 12 (right). Detachment of the mosaic from the east end. The drum is stabilized with supports exploiting lacunae in the mosaic surface.

Figure 13 (below right). Undercutting the mosaic using a fraise.

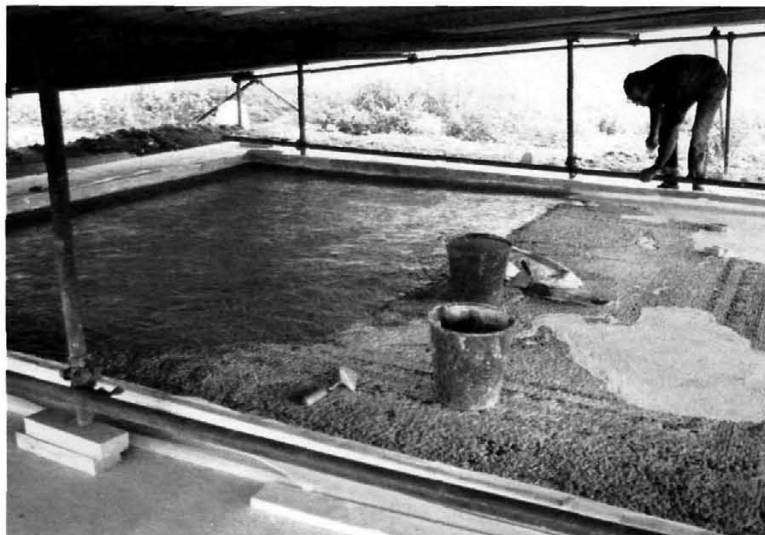
A mortar consisting of five parts white cement, two parts marble powder, one part brick dust, one part aerated pozzolana, and one part Lafarge hydraulic lime was then applied to the back of the mosaic (Fig. 26). The mosaic was fully wetted, to improve adherence, and the mortar was made to penetrate as far as possible into the interstices of the tesserae to provide greater strength. The mortar was beaten with trowels and finally thinned down, to reduce weight and improve flex-

Figure 26. Applying the new mortar to the reverse of the mosaic.

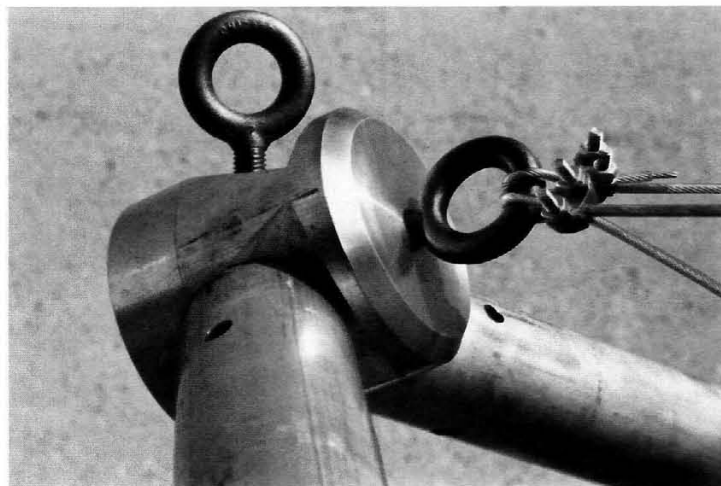
Figure 40. Solid aluminum hub showing two tubing arms in place and two eyebolts. Cables shown connect the three high points of each ring; the other eyebolt is for cabling to concrete anchor blocks. Recessed locking screws secure the arms to the studs threaded to the hub.

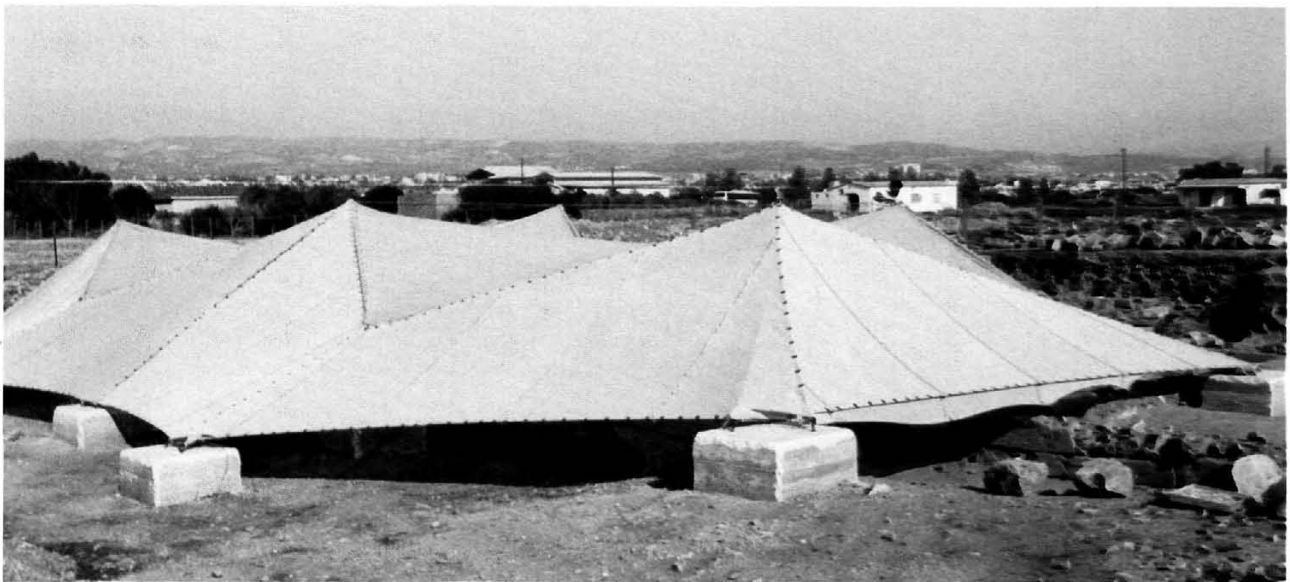
On the other hand the shelter does not provide total protection against the weather. The open-weave side panels break the force of wind and rain, but do not exclude water completely. A water disposal system for roof run-off has yet to be designed and implemented. The Paphos mosaic site is located on a promontory and is therefore exposed. The performance of the hexashelter under severe weather conditions, especially the high winds that occur during winter gales, has yet to be established.

Figure 42. The hexashelter in November 1990 with a new roof membrane and more extensive, overlapping side panels.

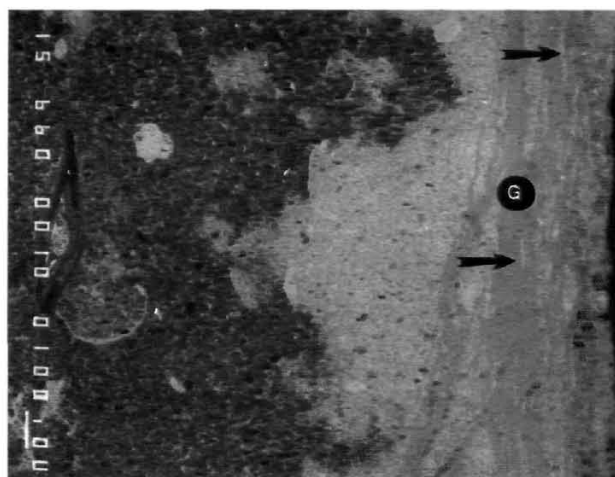
Figure 48 (lower right). Sample 8. Porous calcareous limestone with bands of gypsum (G, arrows) parallel to the surface (right). The gypsum is weak and the surface is flaky. Scale bar is 100 μm .

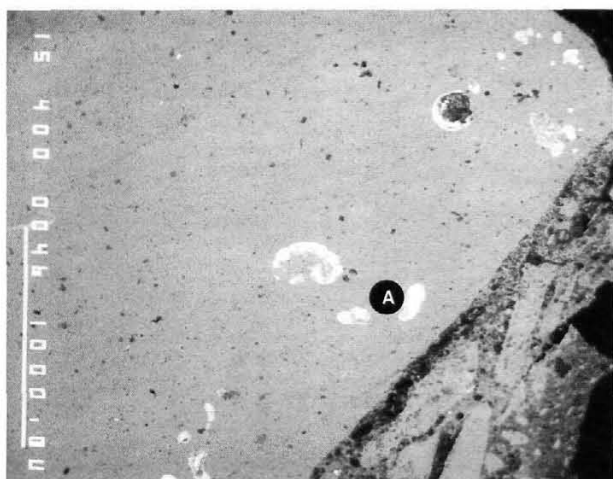
Figure 49 (upper left). Sample 19. Calcareous limestone with iron oxides inside foraminifera (A). Scale bar is 1000 μm .

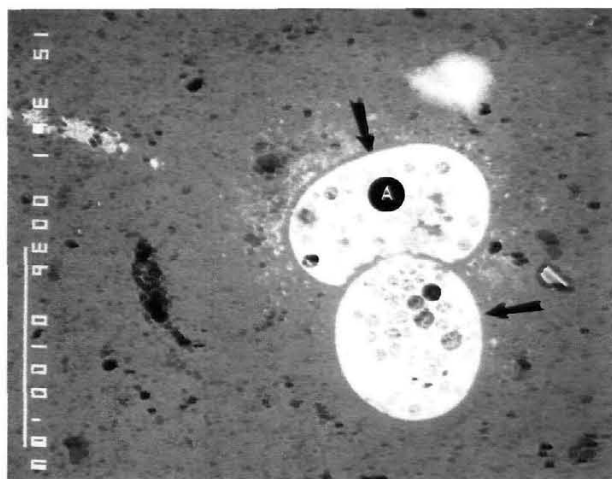
Figure 50 (upper right). Sample 19. Close-up of iron oxides (A) inside foraminifera. Note outline of former shell (arrows). Scale bar is 100 μm .

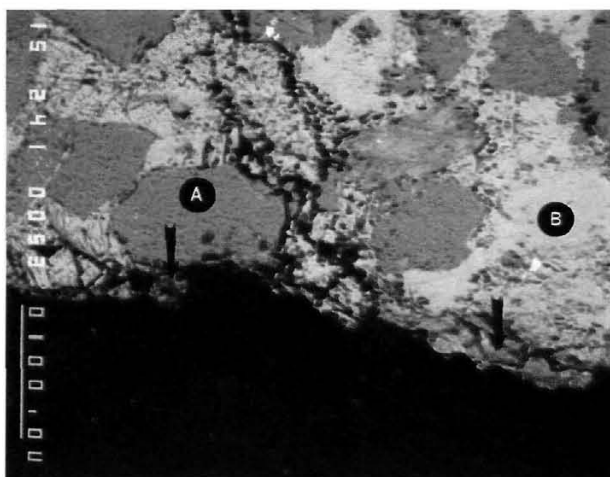
Figure 51 (middle). Sample 21. Sandy, recrystallized limestone. Surface crust is at the bottom of the micrograph and contains gypsum (arrows). Darker grey grains are quartz sand (A); lighter grey is calcite (B). Scale bar is 100 μm .

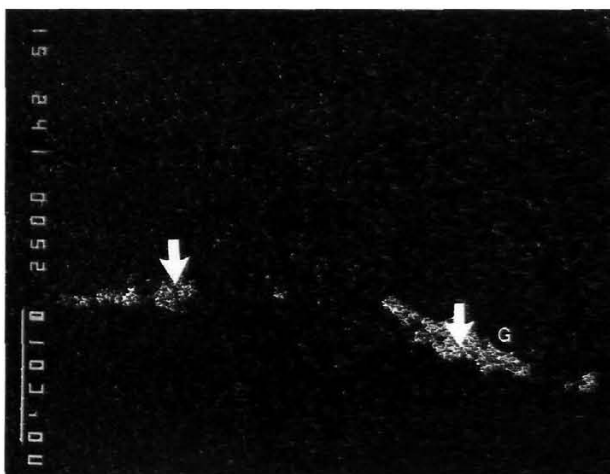
Figure 52 (bottom). X-ray distribution map for sulfur. Sample 21. Note concentration of sulfur (G for gypsum) at surface crust (bottom of micrograph). Same area as Figure 54. Scale bar is 100 μm .

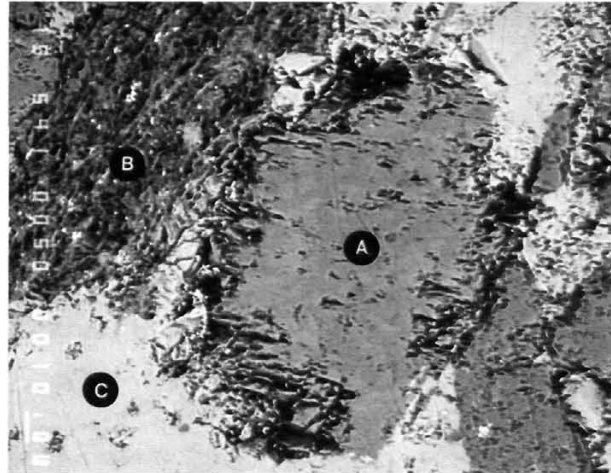
Figure 54 (middle). Sample 21. Sandy, recrystallized limestone. Darker grey grains are quartz sand (A); lighter grey is calcite (B). Note how gypsum follows around quartz grains (intergranular porosity). Scale bar is 100 μm .

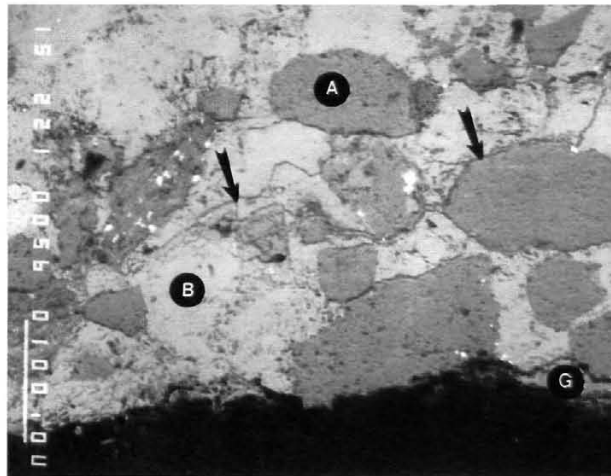
Figure 55 (lower left). X-ray distribution map for sulfur. Sample 21. Concentrations of sulfur (gypsum) penetrate 200–300 μm beneath the surface crust (bottom of micrograph). Same area as Fig. 57. Scale bar is 100 μm .

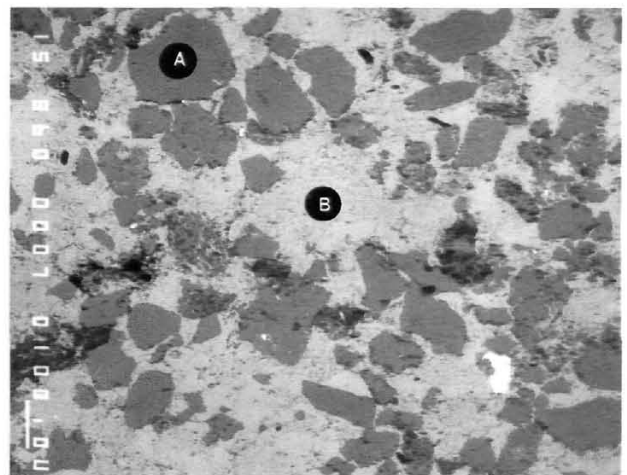
Figure 57 (upper-left). Sample 23. Calcareous limestone with weathering crust (A, right). Scale bar is 100 μm .

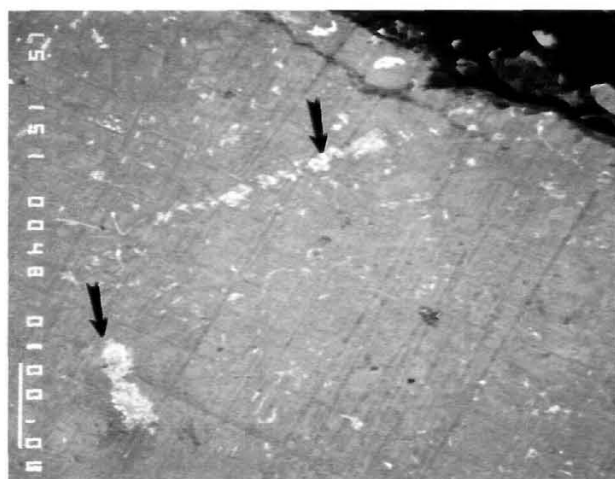
Figure 58 (upper right). Sample 26. Serpentinite with iron oxides (bright particles, arrows). Scale bar is 100 μm .

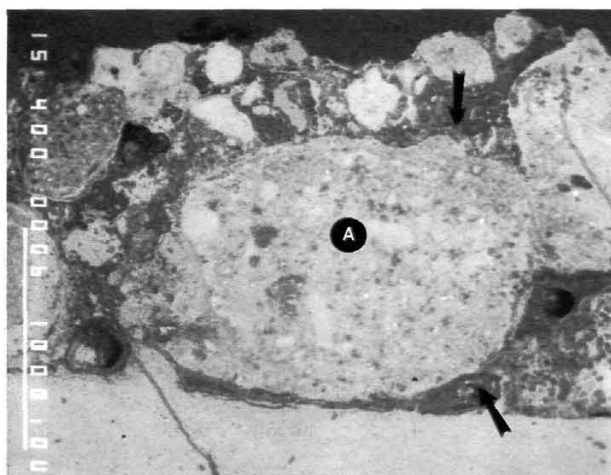
Figure 59 (middle). Sample B. Ancient mortar sample with large grains of calcareous sand (A) cemented by lime mortar (arrows). Scale bar is 1000 μm .

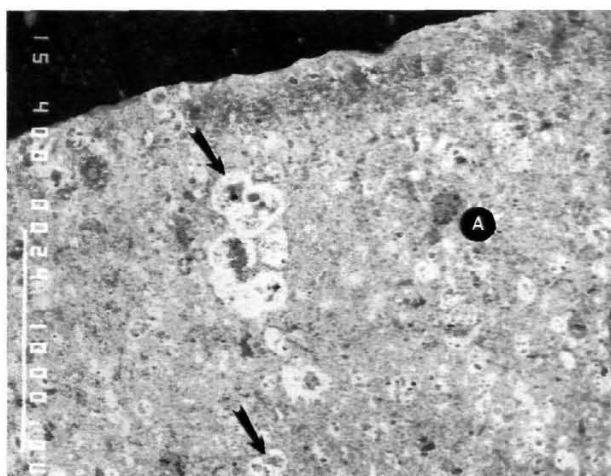
Figure 60 (bottom). Sample SC1. Calcareous limestone with foraminifera fossils (arrows) and rare quartz grains (A). Note fine-grained structure. Scale bar is 1000 μm .

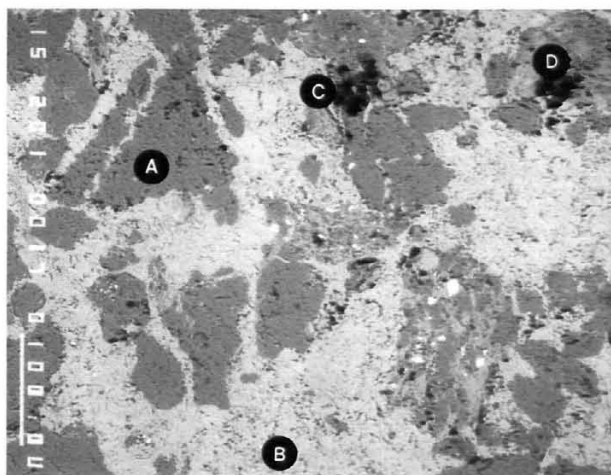
Figure 62 (middle). Sample SC2. Clay seam (A, center) in limestone, forming a weak zone. Scale bar is 100 μm .

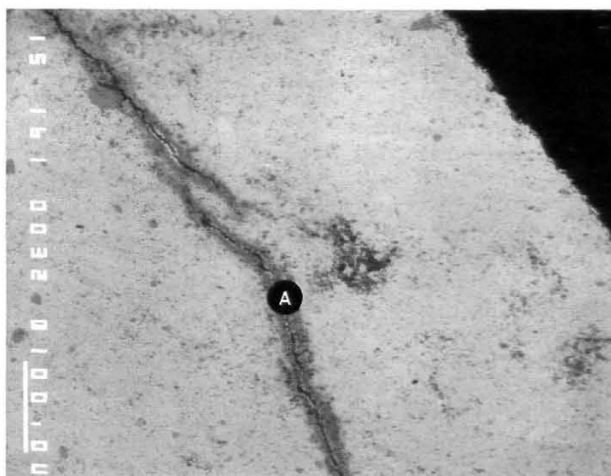
Figure 63 (lower left). Sample SC3. Recrystallized sandy limestone. Area to left is a vein of coarsely crystalline calcite (A). Quartz grains are to the right (B). Scale bar is 100 μm .

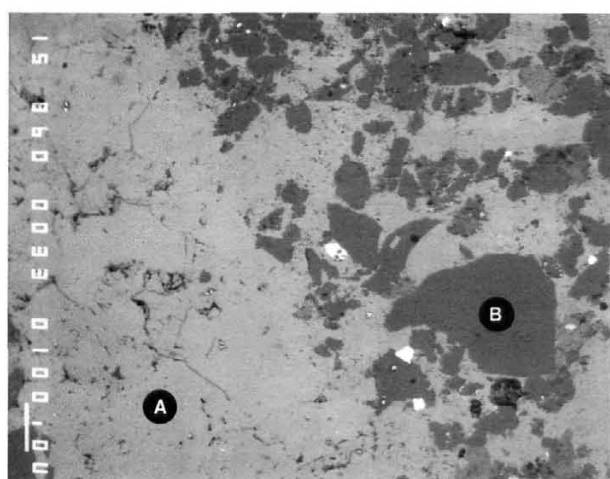
Figure 64 (lower right). Sample SC4. Dolomite (A). Area in center is a calcite vein (B). Etched quartz grains are also present (arrows). Scale bar is 100 μm .

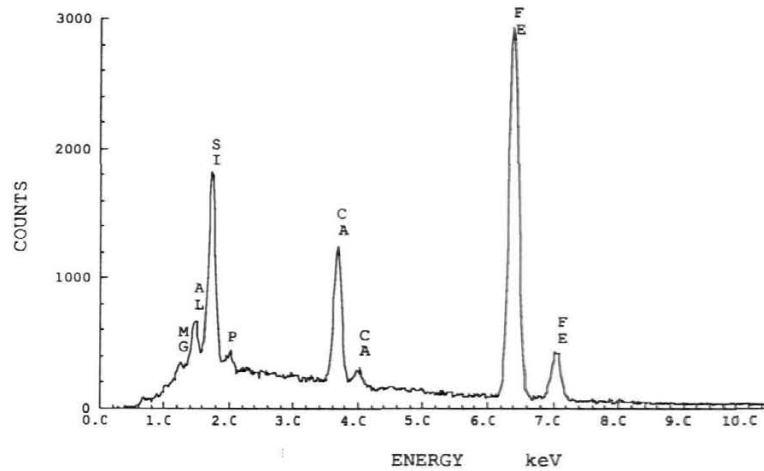
Figure 67 (bottom). Sample 19. Energy dispersive X-ray spectrum of clay layer found in a white stained tessera. The high magnesium content of the clay suggests a mixed layer smectite/illite composition.

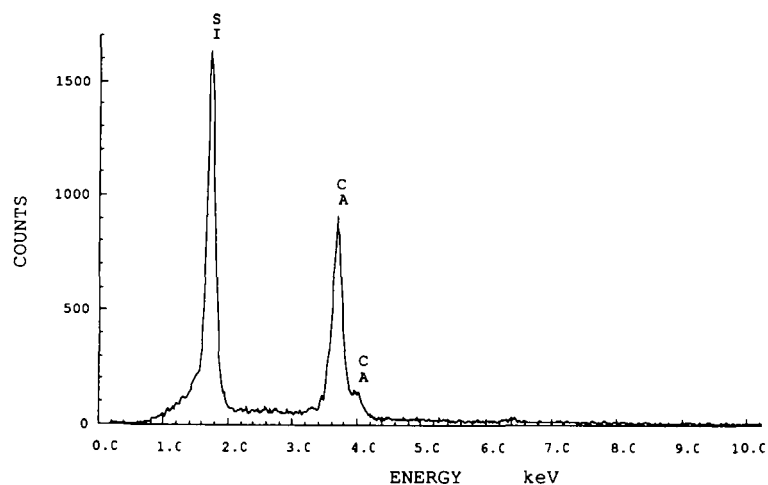
Figure 68 (top). Sample 23.
Energy dispersive X-ray spectrum
of calcite and quartz in a black
unaffected tessera. The high back-
ground noise is probably due to
organic material responsible for
the dark color.

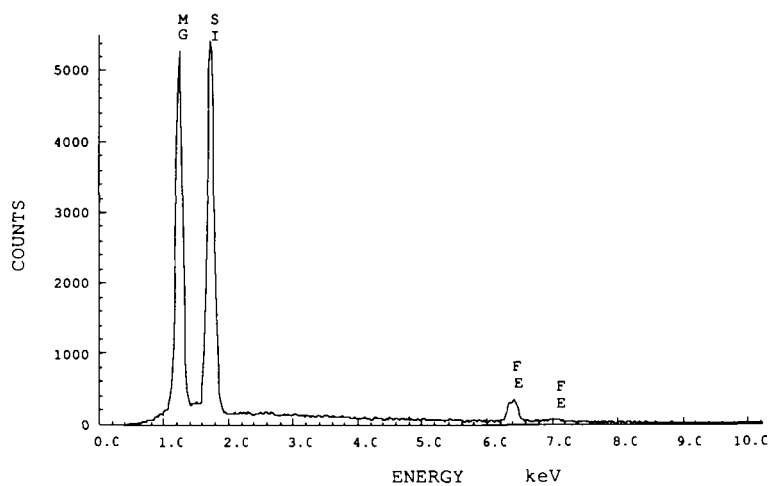
Figure 69 (middle). Sample 26.
Energy dispersive X-ray spectrum
of a problematic greenish black
tessera. The Mg, Si, Fe composi-
tion identifies this stone as serpen-
tinite, a common metamorphic
rock.
